Determination of Effect on Essential Fish Habitat from the Phase V Early Restoration, Florida Coastal Access Project

2.0 Florida Coastal Access Project Description

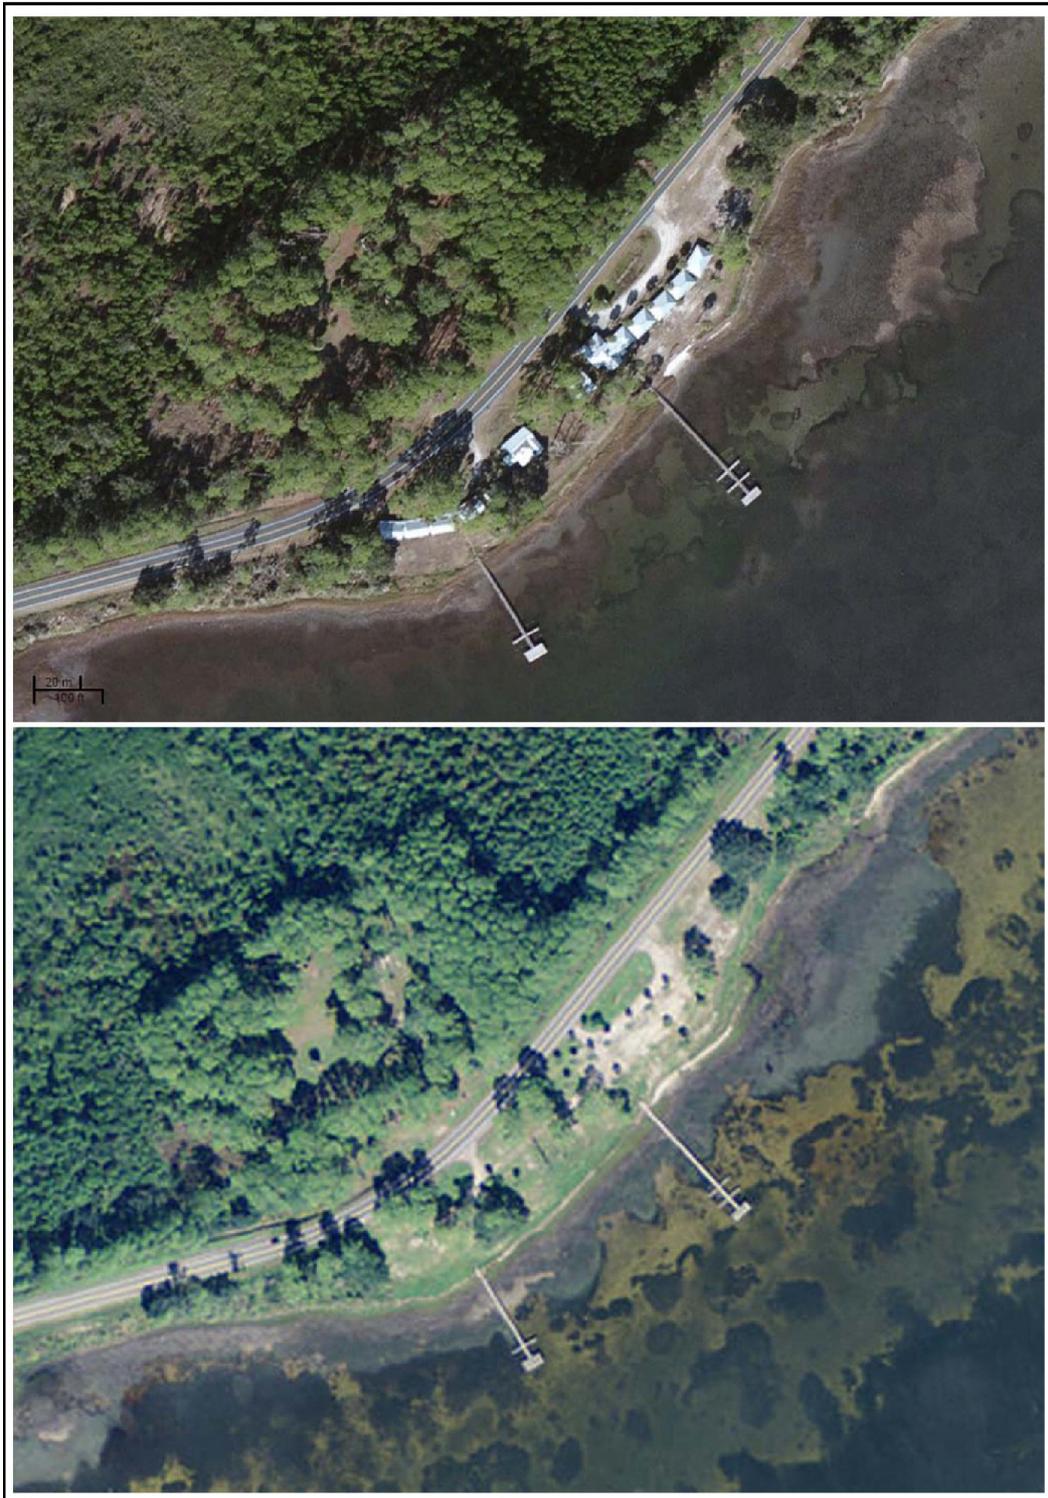
Figure 21: SAV off of the Island View parcel prior to 2013 (top) and post 2013 (bottom). Source: ArcGIS 2015.
